2001 - Fourth International Conference on  
Recent Advances in Geotechnical Earthquake  
Engineering and Soil Dynamics

# GEOTECHNICAL LESSONS LEARNT FROM NEFTEGORSK EARTHQUAKE

**Mark A. Klyachko**

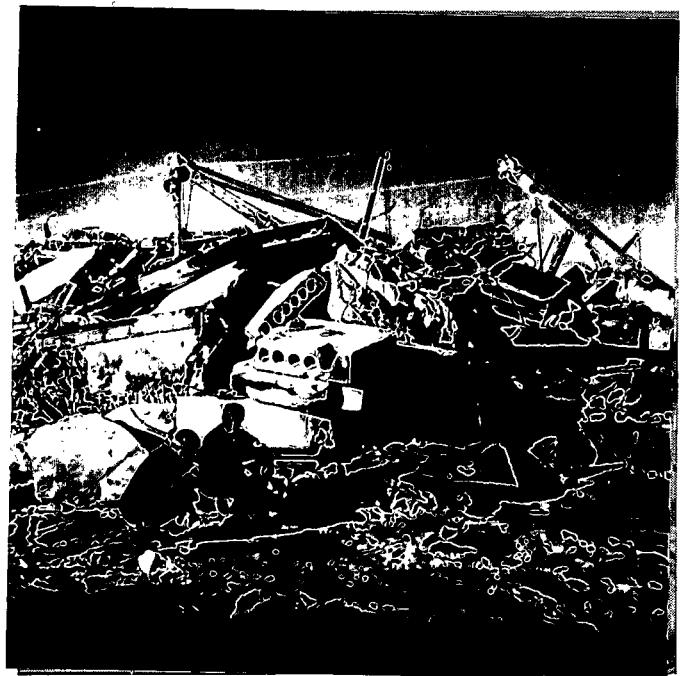
*Fig. 1. 5-storeyed large block houses (damage degree  $d=5$ , full collapse).*

The earthquake in Neftegorsk was the next (after Kobe) great disaster event of 1995. Insidentally, from nearly 2000 victims 90% were killed under collapse of all 17 uniform 5 storey large-block houses of 447-standard. The complete collapse of all houses of this constructional type (Fig. 1) and death of more than 70 % of their inhabitants is a flagrant example in the history of modern construction. Notwithstanding the fact that when being designed such houses were not intended for construction in seismic regions, their mass collapse was statistically unaccountable. According to DIMAK Scale – Scale of Disaster Magnitude - (Klyachko, 1993) the Neftegorsk EQ is estimated as "a great disaster of national scale" ( $M_d=4.53$ ), and an index of relative social vulnerability is calculated as  $p=1.06$ , i.e. very high social vulnerability. The search of reasonable explanation in this connection is likely to prevent similar seismic tragedies and to select a correct approach to the use of such large-block houses built on the seismo-prone areas.

The additionally neglected "B" factor was a dynamic quick increase of pressure on sands under the foundation bottom exceeding the design value twofold due to vertical EQ-component estimated by PGA of up to 0.8g. The joint damage-forming impact of the two important factors "A" and "B" was manifested as vibro-settlement in the most stressed place - under the foundation bottom of the medium bearing wall of the 5-storey building. It is exactly the combination of "A" and "B" factors characteristic of 447-standard houses that was the main cause of the Neftegorsk tragedy. Such effect in 2-3 storied buildings was not noticed (Fig. 2).

- collapse of all seventeen 447 – standard houses happened in one and the same way - inwards, resulting from vibro-settlement of the foundation of the medium wall (axe B); according to the data of population inquiry the seismic impact was represented by 2 successive short heavy shocks: upwards and sideways;

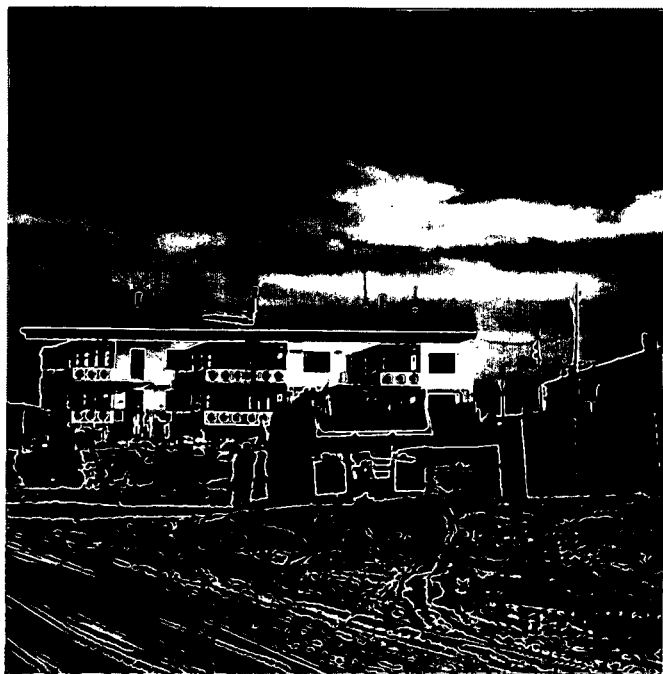
Fig. 2. Two – storied large block houses (damage degree  $d=1$ ).

of other apartment houses built also ignoring antiseismic measures, the building of a polyclinic and a kindergarten made of large ceramsite concrete blocks (Fig. 2) confirm indirectly unfitness of the "constructional version" as the main cause of Neftegorsk tragedy.
